Site Reassessment

SITE REASSESSMENT REPORT

Camdenton Sludge Disposal Area Site Camden County, Missouri

March 11, 2019

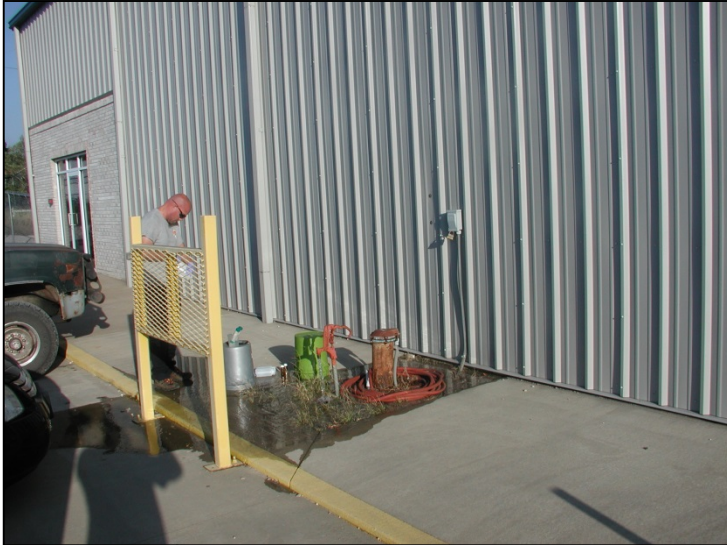
Photograph 1
Camdenton Sludge Disposal Area Site
Camdenton, Camden County, MO
Photo taken 10/02/2017 by
Keith Brown,
DEQ, HWP, SF

Photograph of well spigot at Location 101 during sampling. Photo taken facing north.

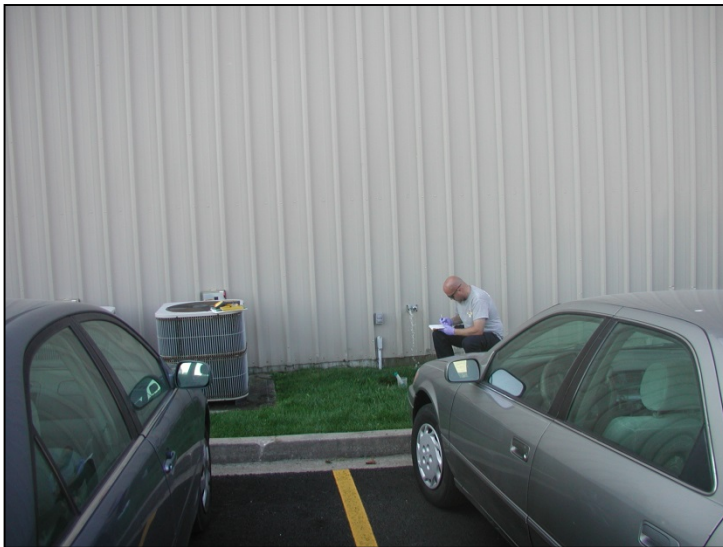
Photograph 2
Camdenton Sludge Disposal Area Site
Camdenton, Camden County, MO
Photo taken 10/02/2017 by
Keith Brown,
DEQ, HWP, SF

View of well spigot at Location 102 during 5 minute purge prior to sampling. Photo taken facing south.

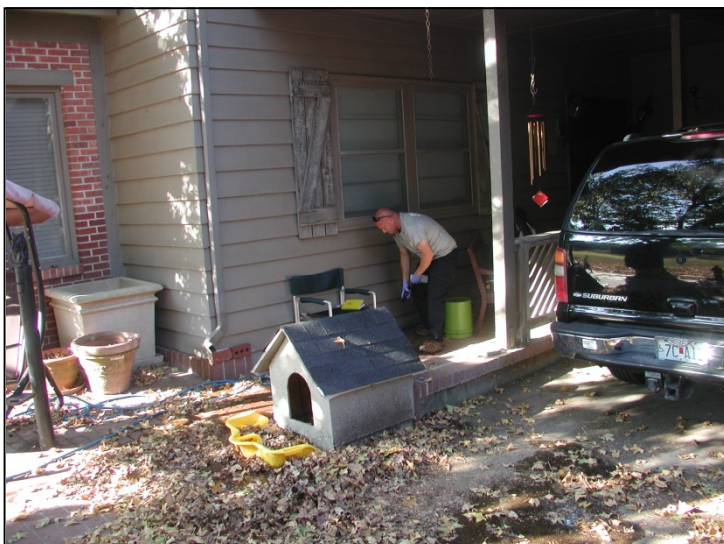
Photograph 3
Camdenton Sludge Disposal Area Site
Camdenton, Camden County, MO
Photo taken 10/02/2017 by
Keith Brown,
DEQ, HWP, SF

Picture of Location 103 during sampling. Photo taken facing south.

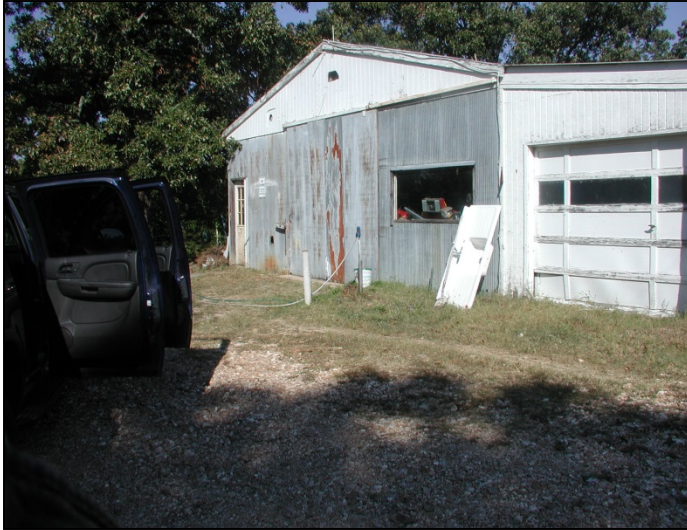
Photograph 4
Camdenton Sludge Disposal Area Site
Camdenton , Camden County, MO
Photo taken 10/02/2017 by
Keith Brown,
DEQ, HWP, SF

Photograph of well Spigot (with hose attached) for location 104. Photograph was taken facing north.

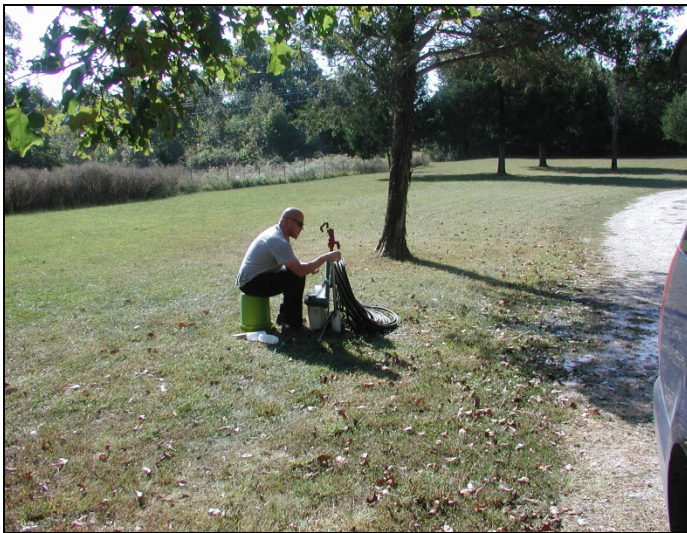
Photograph 5
Camdenton Sludge Disposal Area Site
Camdenton , Camden County, MO
Photo taken 10/02/2017 by
Keith Brown,
DEQ, HWP, SF

Picture depicts sampling preparations for well spigot at location 105. Photograph was taken facing east.

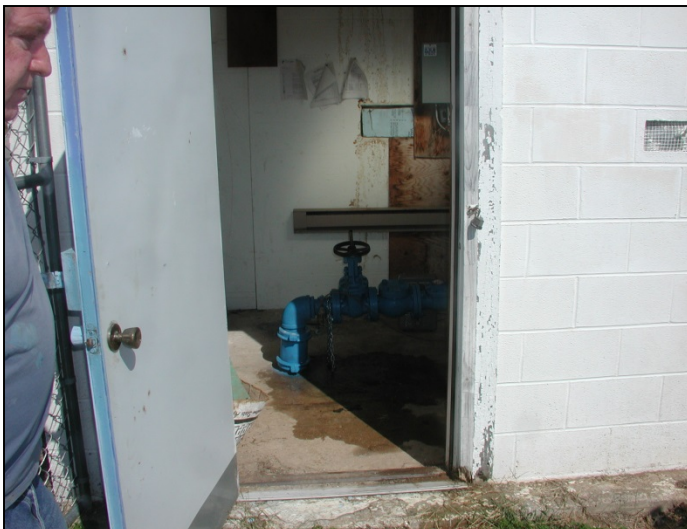
Photograph 6
Camdenton Sludge Disposal Area Site
Camdenton , Camden County, MO
Photo taken 10/02/2017 by
Keith Brown,
DEQ, HWP, SF

Photograph of pump station for Camden County PWSD #2 Well #1 (Location 106-Airport Well).

Chromium was detected at 4.41 µg/L in the public Camden County PWSD#2 Well #1 groundwater sample, which is below the MCL of 100 µg/L. Following the detection of chromium the public well was resampled for hexavalent chromium analysis and was found to have 0.31 µg/L Cr⁺⁶ which is below the Removal Management Level for Cr⁺⁶. Chromium was not detected in any of the other groundwater samples collected during the Site Reassessment. No further Superfund response action is required at this time.

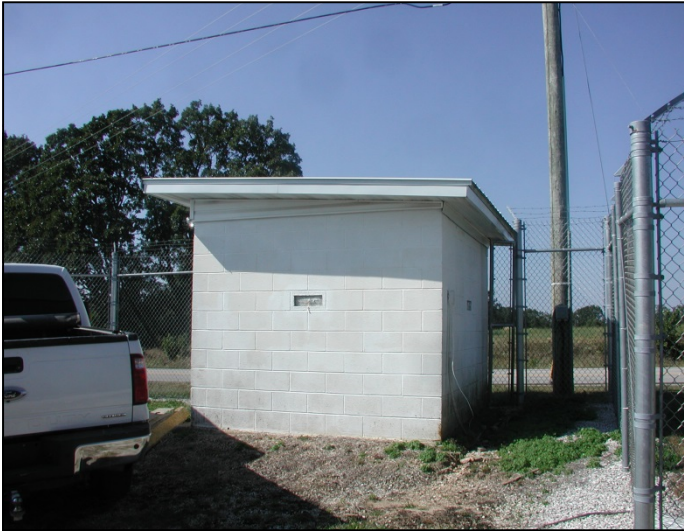
Photograph 7

View of Camden County PWSD #2 Well
#2 (Location 106) pump house.
Photograph was taken facing west.

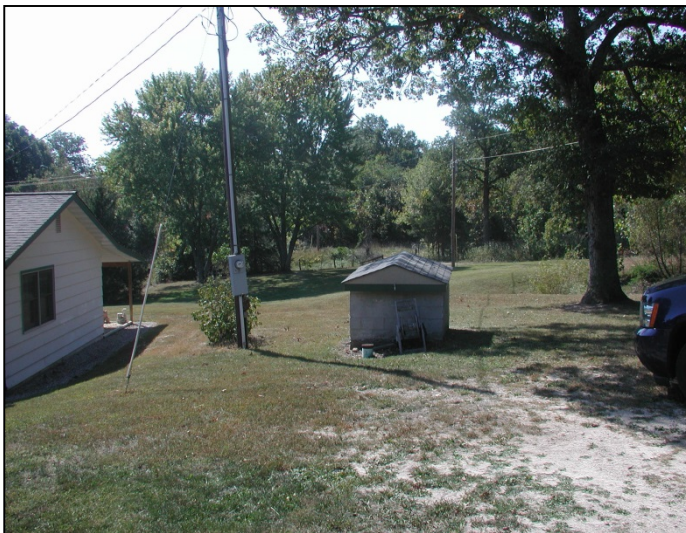
Photograph 8

Picture of well pump house at Location
107. Photograph was taken facing south.

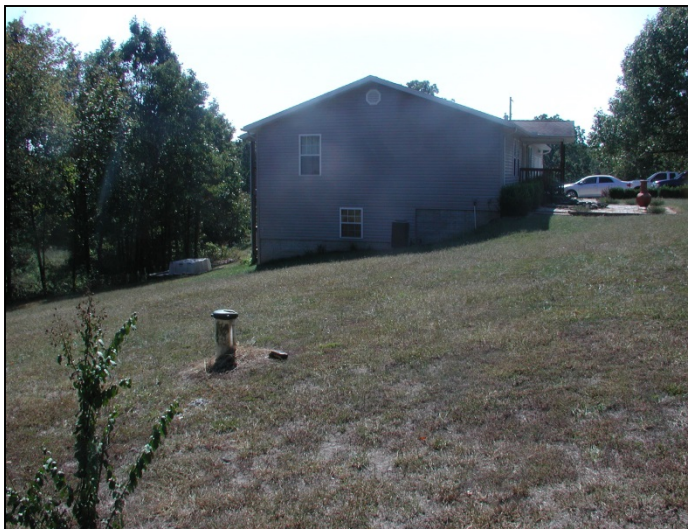
Photograph 9

Photograph of well cap at Location 108.
Well stem and portable GPS unit are in the
foreground. Photograph was taken facing
south.

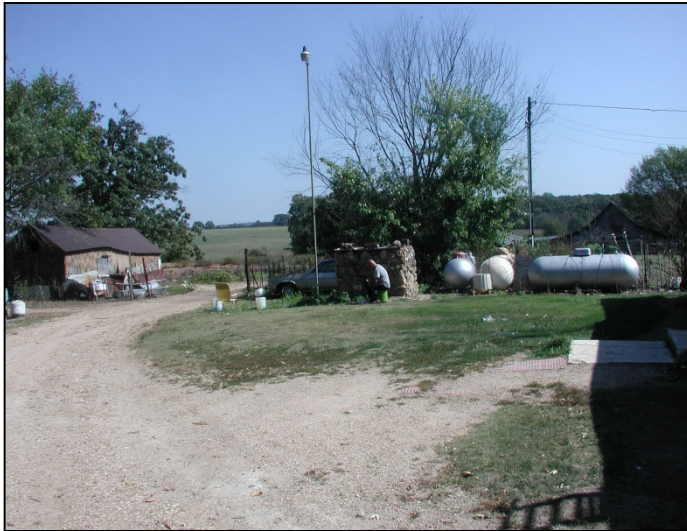
Photograph 10
Camdenton Sludge Disposal Area Site
Camdenton, Camden County, MO
Photo taken 10/02/2017 by
Keith Brown,
DEQ, HWP, SF

Photograph of Location 109 during sampling. Well shaft is within stone structure near propane tanks. Photograph was taken facing east.

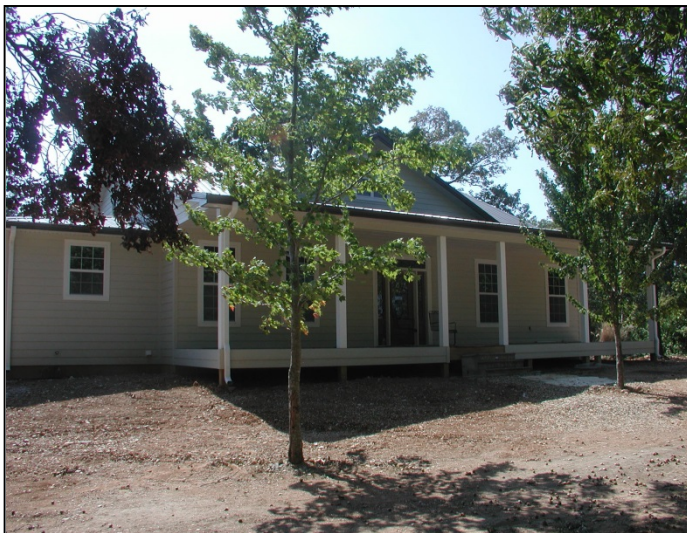
Photograph 11
Camdenton Sludge Disposal Area Site
Camdenton, Camden County, MO
Photo taken 10/02/2017 by
Keith Brown,
DEQ, HWP, SF

Picture of house at Location 110.
Photograph was taken facing south.

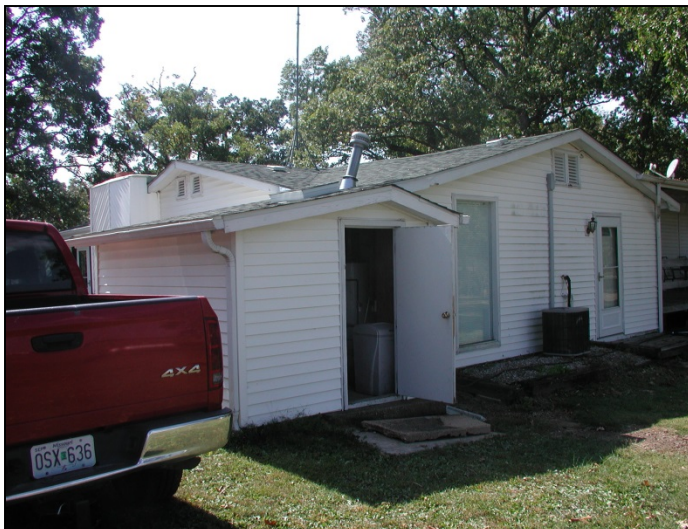
Photograph 12
Camdenton Sludge Disposal Area Site
Camdenton, Camden County, MO
Photo taken 10/02/2017 by
Keith Brown,
DEQ, HWP, SF

Photograph of pump house at Location 111. Well casing and pump are enclosed in the portion of the building with the door ajar. Photograph was taken facing south.

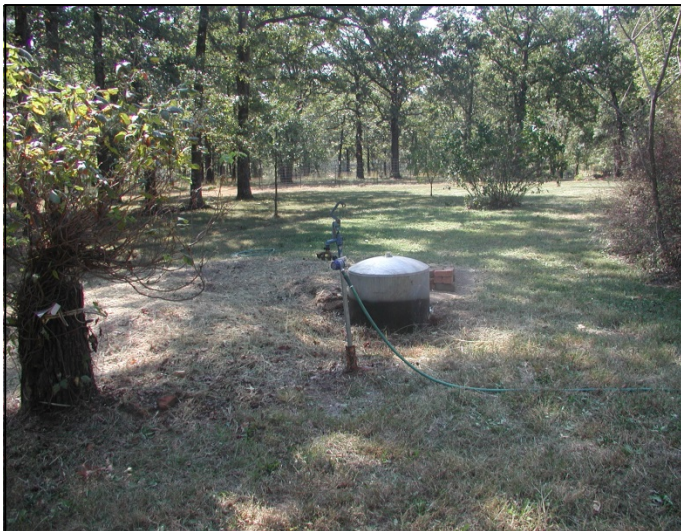
Photograph 13

Photograph well spigot where sample was collected at Location 112. Photograph was taken facing south.

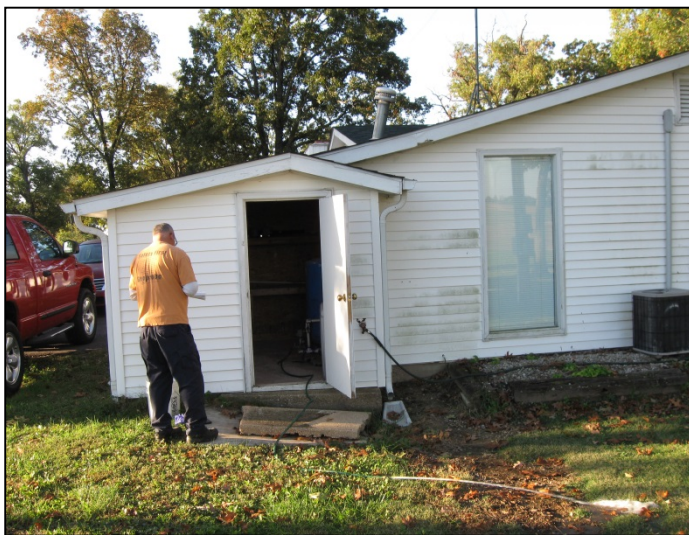
Photograph 14

Picture of ESP staff resampling the well at Location 111. Photograph was taken facing south.

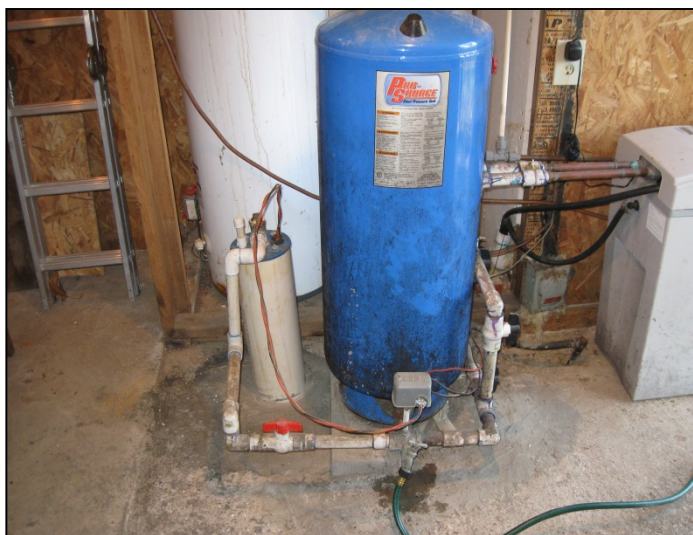
Photograph 15

Photograph of ESP well head and water tank at Location 111 during resampling.

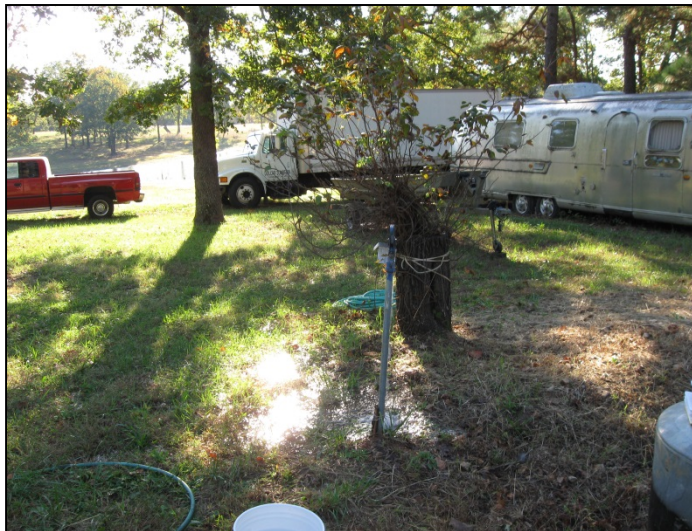
Photograph 16

Picture of well spigot at Location 111
during resampling. Photograph was taken
facing south.

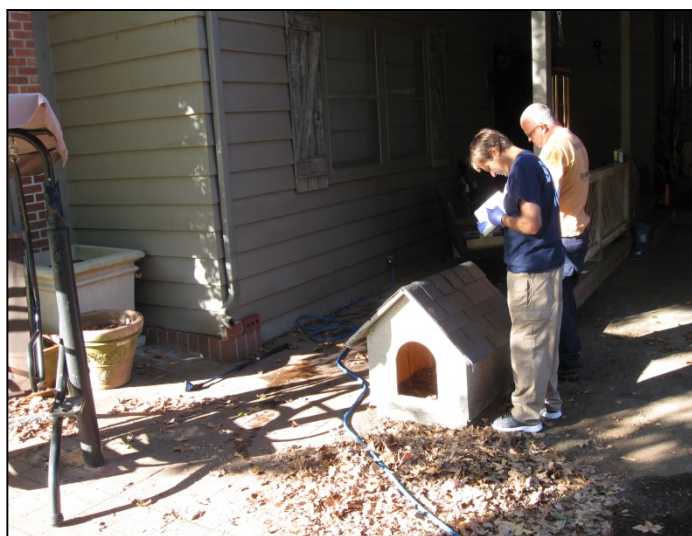
Photograph 17

Picture of ESP staff monitoring
parameters from the well spigot at
Location 103 during resampling.
Photograph was taken facing south.

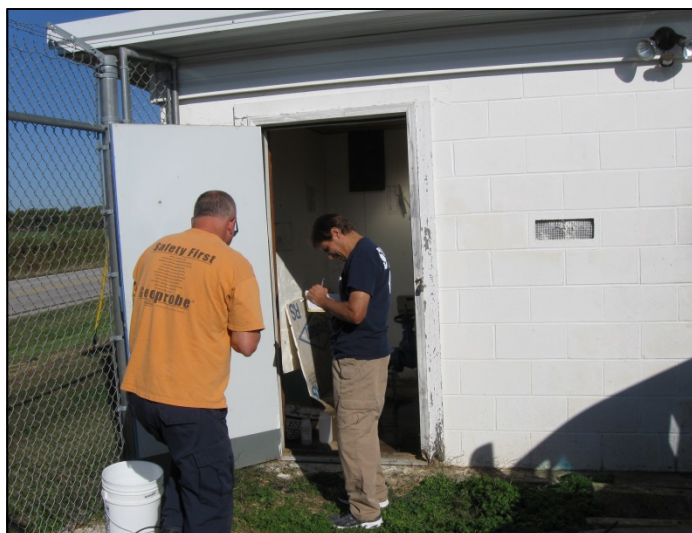
Photograph 18

Photograph depicts ESP staff collecting
water quality parameters prior to
resampling of Camden County Public
Water Supply District #2 Well #1
(Location 106). Photograph was taken
facing north.

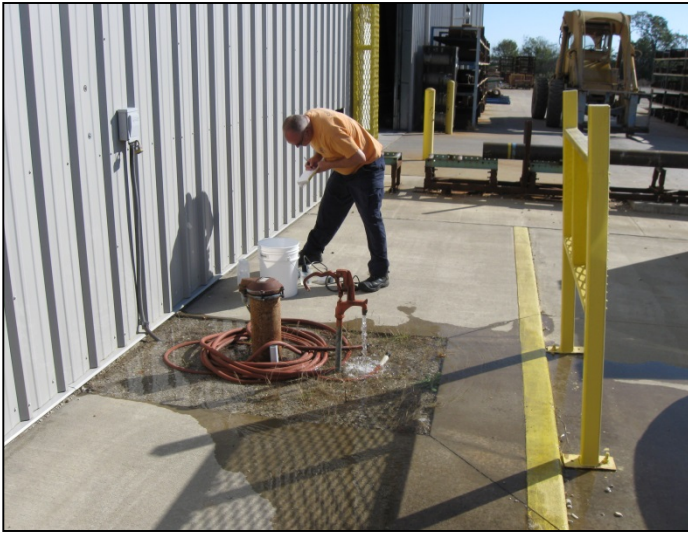
Photograph 19

View of ESP conducting resampling of well at Location 101. Photograph was taken facing east.

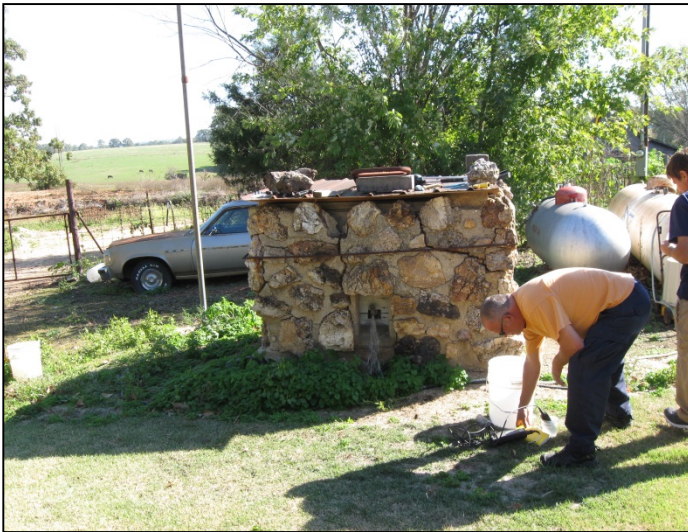
Photograph 20

Photograph depicts ESP staff conducting resampling of well at Location 109. Photograph was taken facing east.

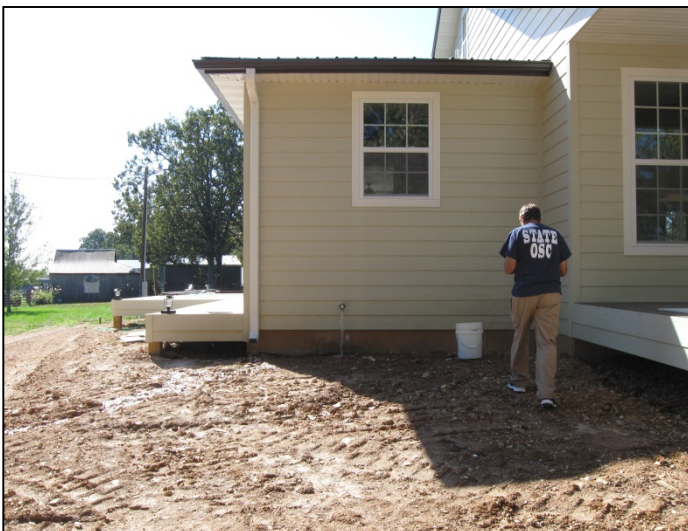
Photograph 21

Picture shows ESP staff accessing well spigot (attached to outer wall of home) for resampling at Location 110. Photograph was taken facing south.

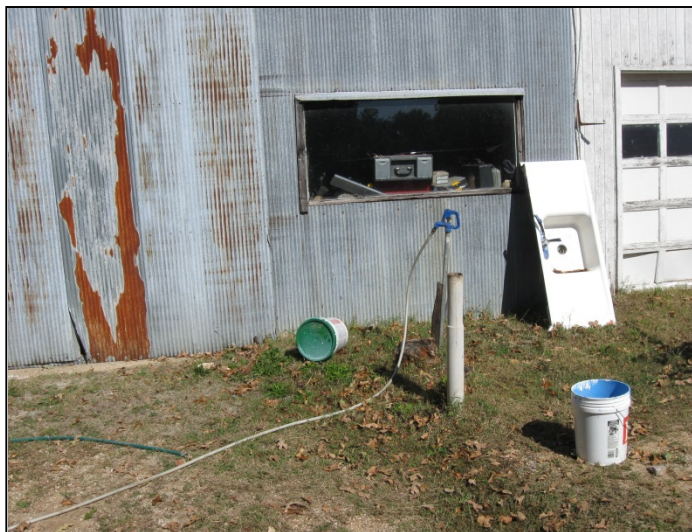
Photograph 22

Photograph of well spigot at Location 104 during resampling. Hose was connected during purging and was disconnected prior to actual sampling. Photograph was taken facing north.

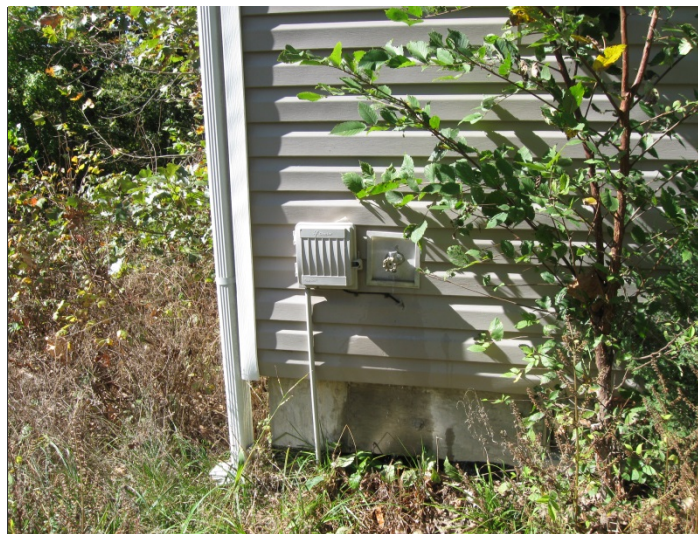
Photograph 23

Picture of well spigot at Location 123 during initial round of sampling. Photograph was taken facing west.

Due to elevated lead detected in the well water at Location 123, thought to be related to lead mining in the area, it was determined that the well may not be representative of general water quality conditions in the Ozark Aquifer. Therefore, only water quality data from well location 118 were used to represent background groundwater conditions for the site (Table 7). The background sample from location 118 did not detect any total chromium and had 0.013 µg/L of hexavalent chromium which is below all of the relevant screening levels. Lead was not detected in the Location 118 sample. Although barium, copper and zinc were measured at low levels in the groundwater sample from Location 118, no metals were detected at levels above the National Primary or Secondary Drinking Water Standards (Table 7).

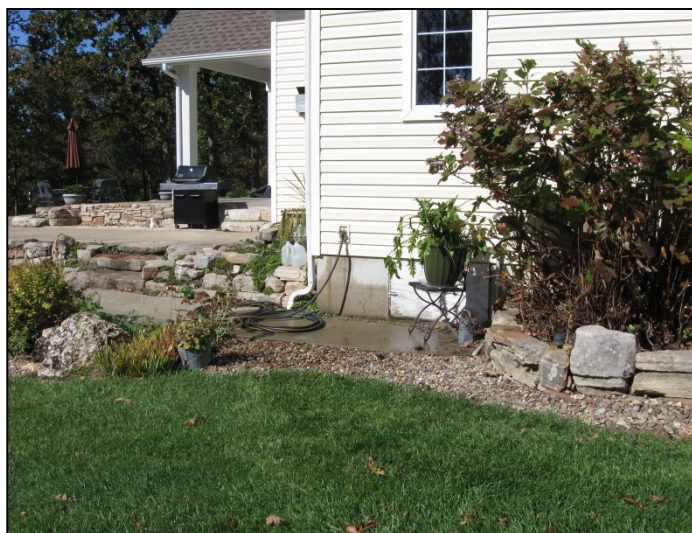
Photograph 24

Photograph of well spigot at Location 118 during initial round of sampling. Photograph was taken facing west.

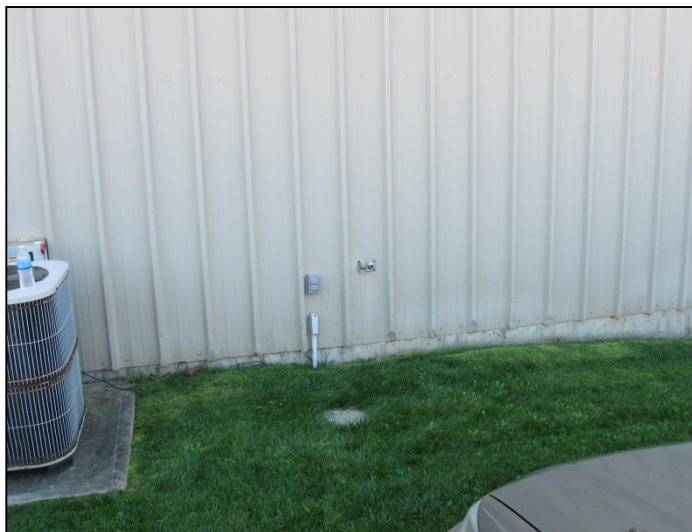
Photograph 25

Picture shows an up close view of the well spigot at Location 102 during resampling. Photograph was taken facing south.

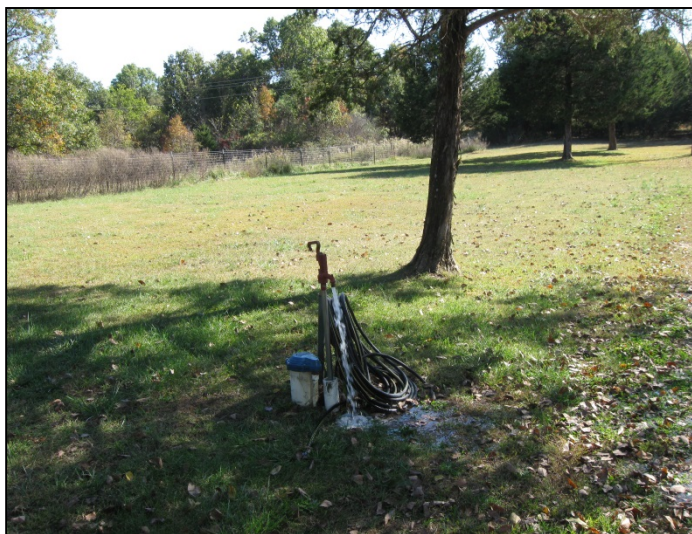
Photograph 26

Photograph of well spigot at Location 105 during resampling. Hose was attached during purging and was disconnected prior to actual sampling. Photograph was taken facing north.

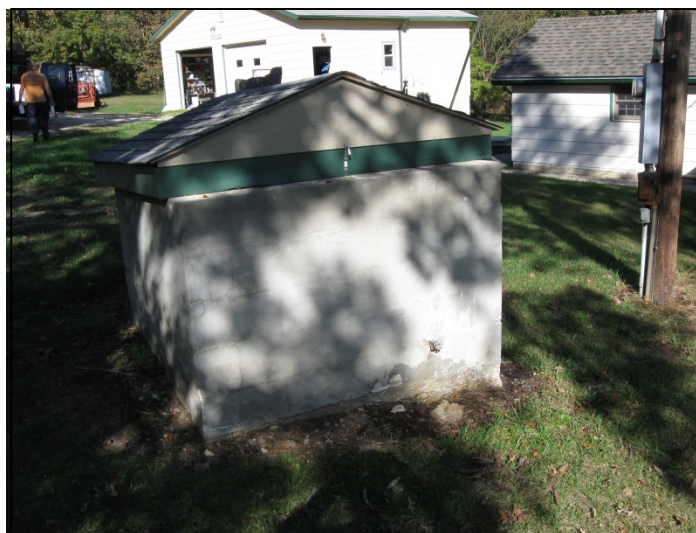
Photograph 27

Well housing for location 107 is depicted in the foreground of photograph. ESP staff are conducting resampling in the background.

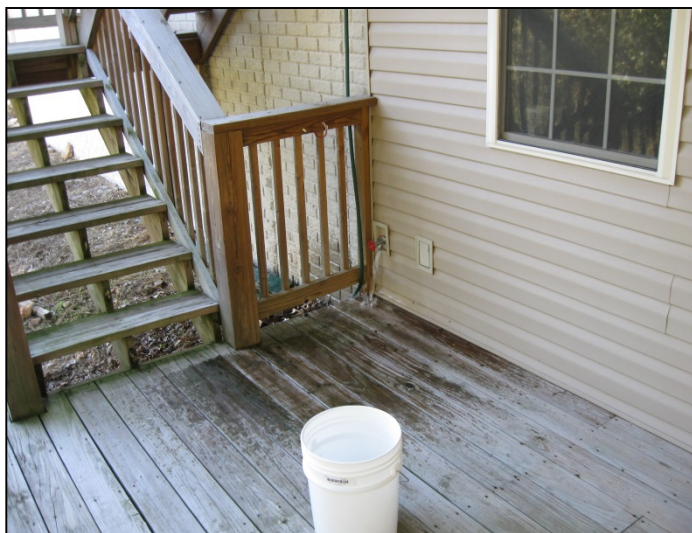
Photograph 28

Camdenton Sludge Disposal Area Site
Camdenton, Camden County, MO
